PENNSYLVANIA
NDS ID PA. 00682
DER ID 54-12

PARK PLACE DAM NO. 3

PHASE I INSPECTION REPORT NATIONAL DAM INSPECTION PROGRAM

WOODWARD-CLYDE CONSULTANTS ✓
5120 Butler Pike
Plymouth Meeting, Pennsylvania 19462

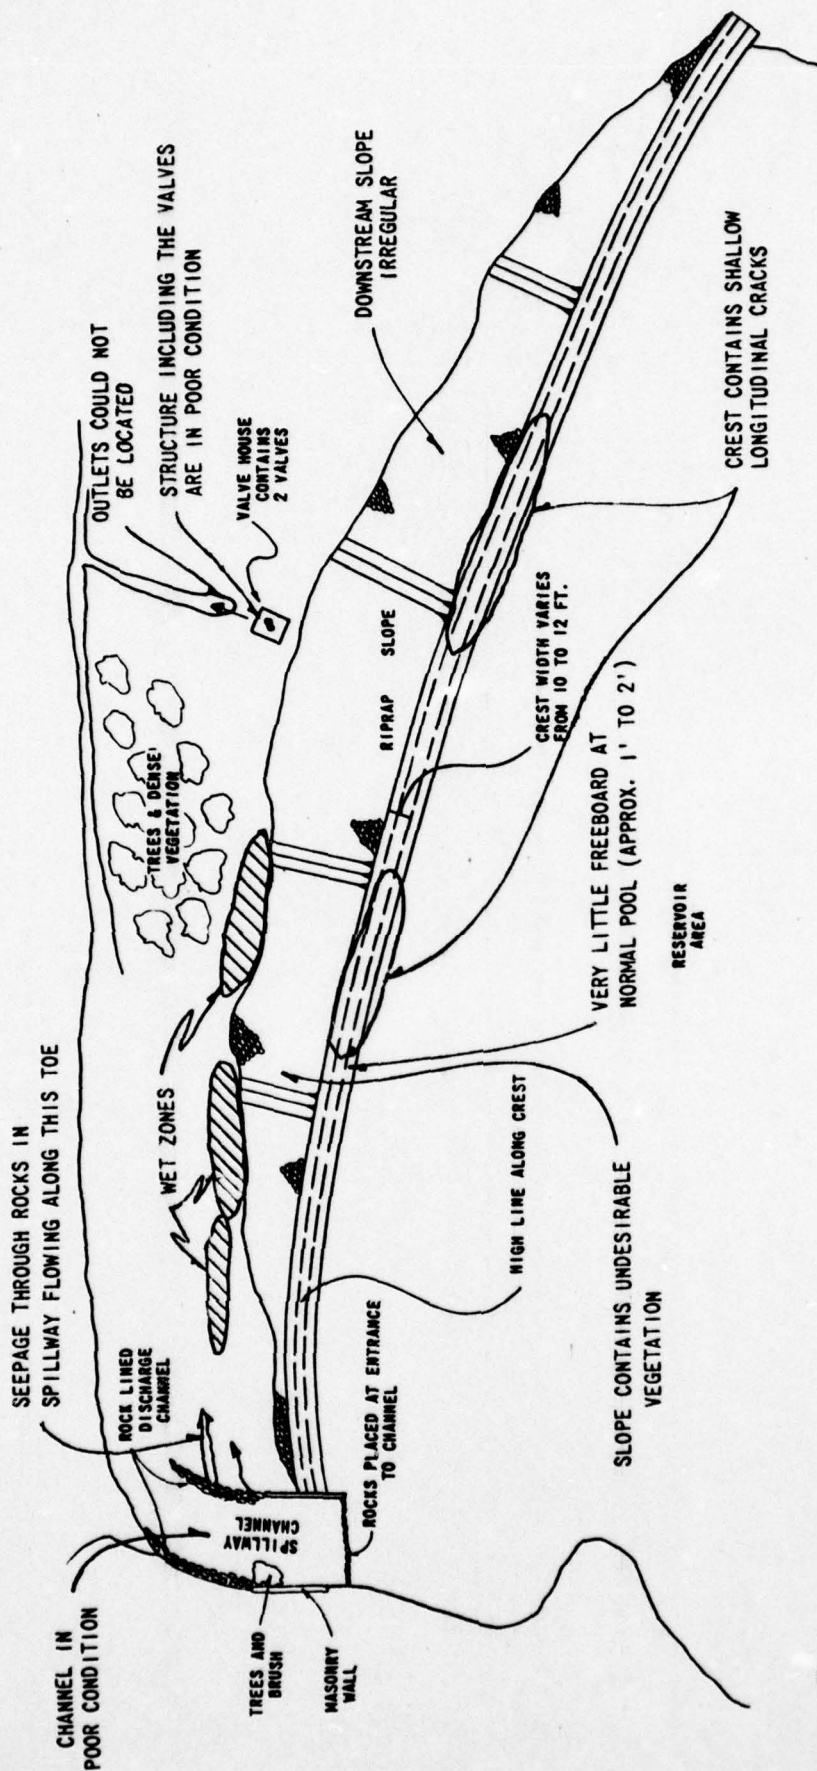
Sheet 4 of 11

VISUAL EXAMINATION OF	OBSERVATIONS	REMARKS OR RECOMMENDATIONS
SURFACE CRACKS	Yes. Some longitudinal cracking was noted along the downstream and upstream sides of the crest as shown on Sheet 5a. These cracks do not appear to be deep and may be associated with freeze-thaw cycles.	
UNUSUAL MOVEMENT OR CRACKING AT OR BEYOND THE TOE	None observed.	
SLOUGHING OR EROSION OF EMBANKMENT AND ADJUTMENT SLOPES	None observed.	
VERTICAL AND HORIZONTAL ALIGNMENT OF THE CREST	Horizontal and vertical alignment was checked and found to be reasonably good with no significant vertical undulation or abrupt or unusual horizontal movements.	
RIPRAP FAILURES	No failures were observed but the slope is non-uniform both longitudinally and perpendicular to the centerline. Long-term movement of the slope is obvious.

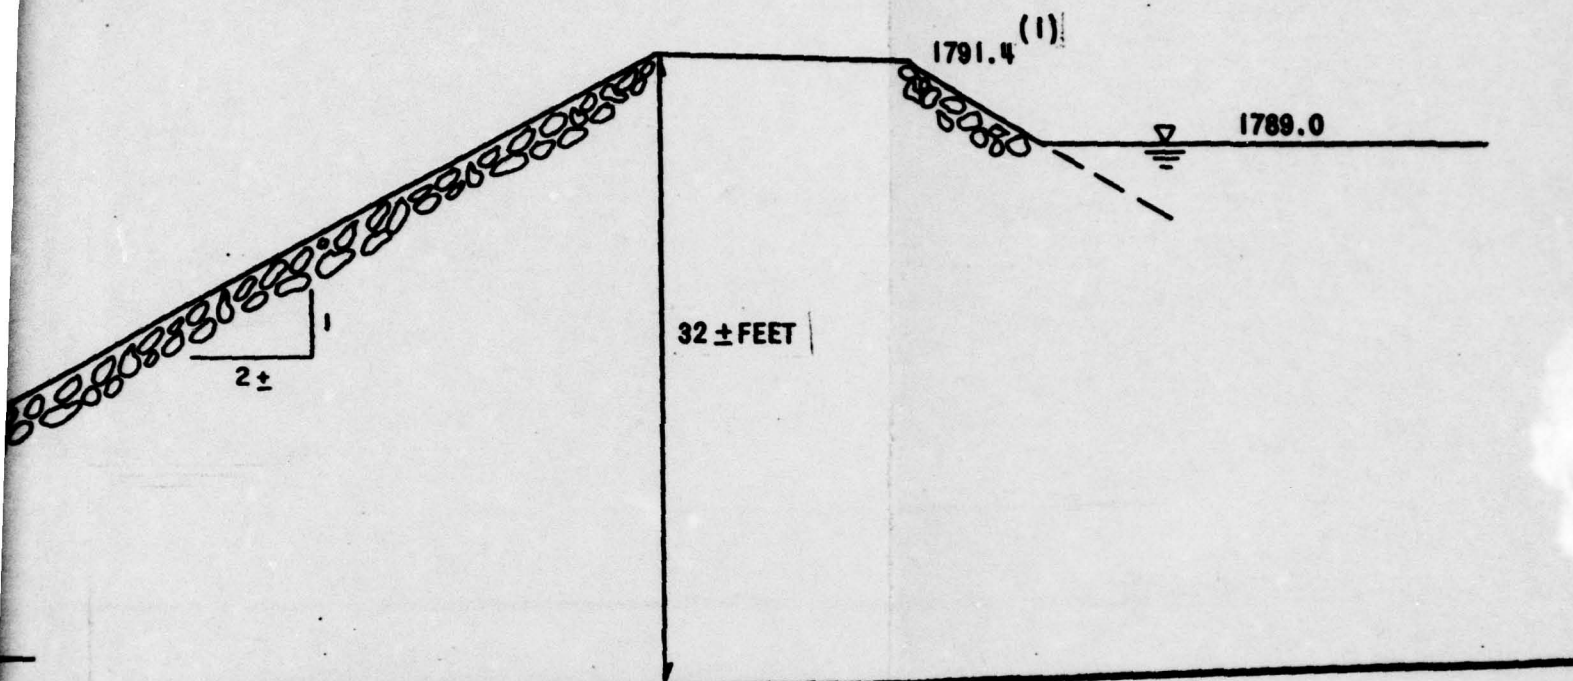
SECTION A-A
(SEE PLATE 2)

8" PIPE (LOCATION INFERRED FROM A DEC. 1909 DRAWING)
